PROJECT #LPB49520

Project consists of isolated shell and core improvements to the downtown Macy's building.

3rd & Pine Redevelopment Project

21 DEC 2020

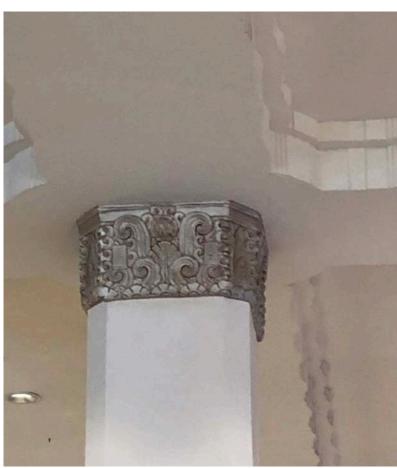
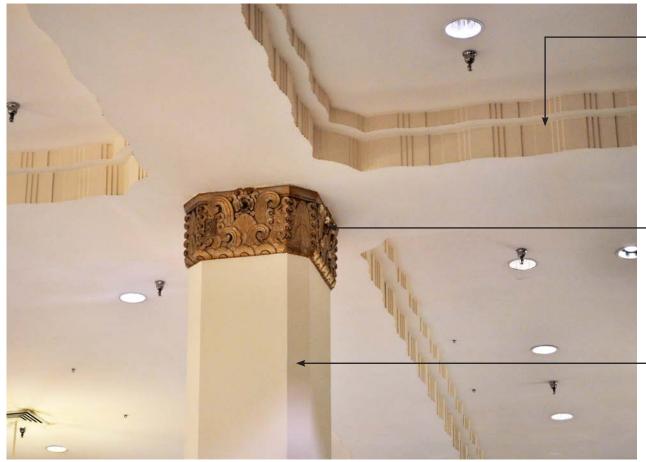
__ EXISTING HISTORIC
DECORATIVE PLASTER TRIM AT
FALSE BEAMS*.
SEE NOTE ABOVE.

EXISTING HISTORIC DECORATIVE PLASTER COLUMN CAPITAL*. SEE NOTE ABOVE.

EXISTING COLUMN SHAFT.

DIRECT APPLIED PLASTER
TO CONCRETE COLUMN.

*HISTORIC DECORATIVE PLASTER: HEMP FIBER BINDER & PLASTER.

NEW DECORATIVE PLASTER
WORK TO BE FORMED FROM
MOLDS MADE FROM THE
EXISTING HISTORIC TRIM AND
CAPITAL, COMPOSED OF THE
SAME MATERIALS & FINISHED TO
MATCH EXISTING HISTORICAL
ELEMENTS.

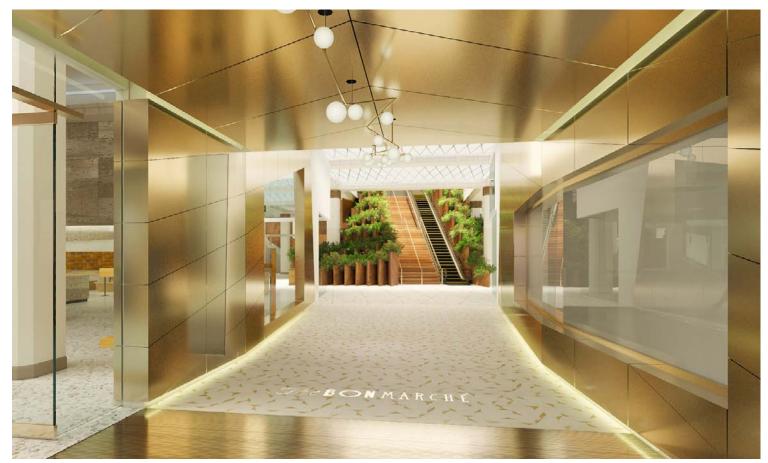
Existing historic coffers and column capitals to remain

Proposed Portal Entrance Item 2A

Proposed Common Area Item 2B Illuminated ceiling element introduced between historic decorative coffers Existing ceiling above

remains intact

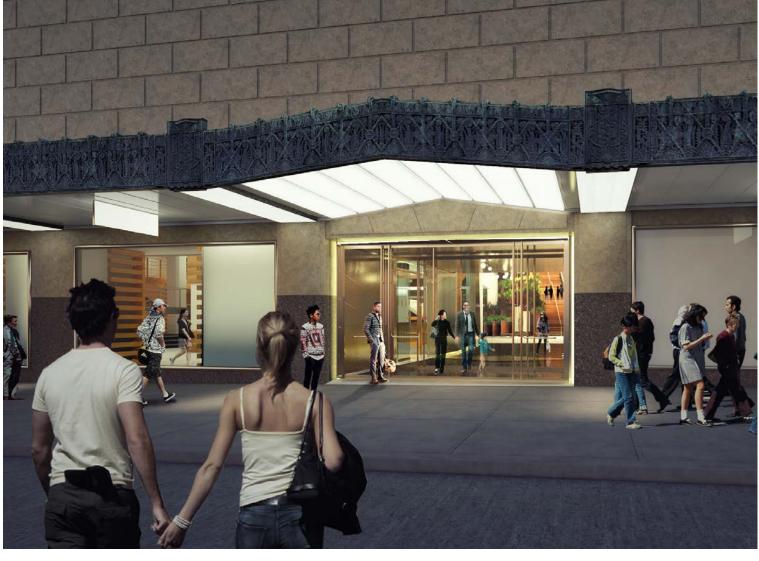
Proposed Entry 2.5

ITEM 3. EXTERIOR: Replace existing door assembly at Entry 2.5 to create new main entry statement.

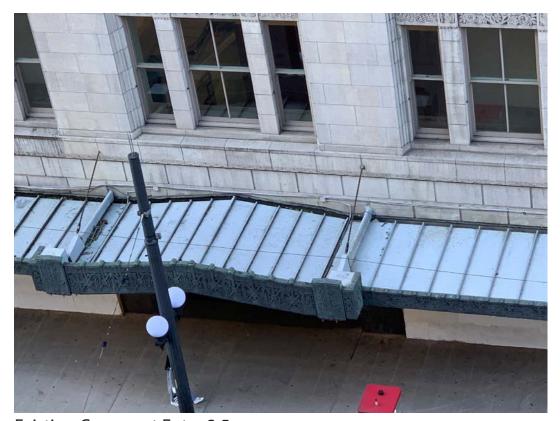
Existing Canopy at Entry 2.5

- Remove existing roof metal plate and replacing with translucent panel and lighting assembly within existing marquee canopy structure at Entry 2.5 and Entry 8

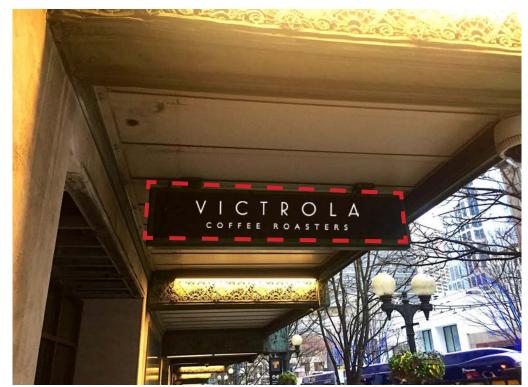
EXISTING PINE ST EXTERIOR BLADE SIGNAGE CABINET FOR REFERENCE.

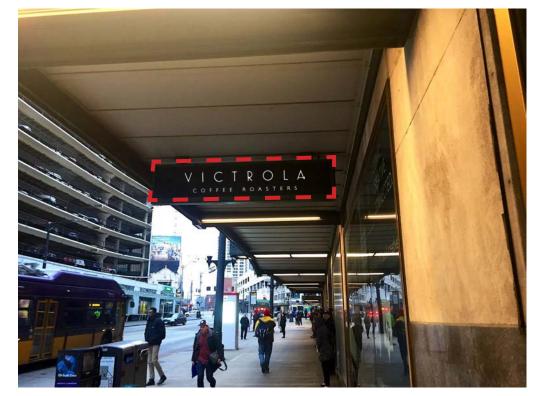
3RD AVE PROPOSED NEW BLADE SIGNAGE CABINET TO MATCH **EXISTING CABINET DIMENSIONS, FINISHES AND ATTACHMENT** DETAIL.

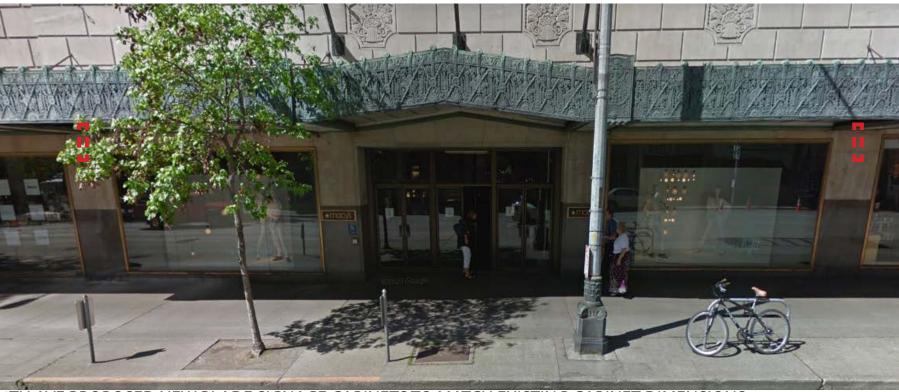
4TH AVE PROPOSED NEW BLADE SIGNAGE CABINETS TO MATCH EXISTING CABINET DIMENSIONS, FINISHES AND ATTACHMENT DETAIL.

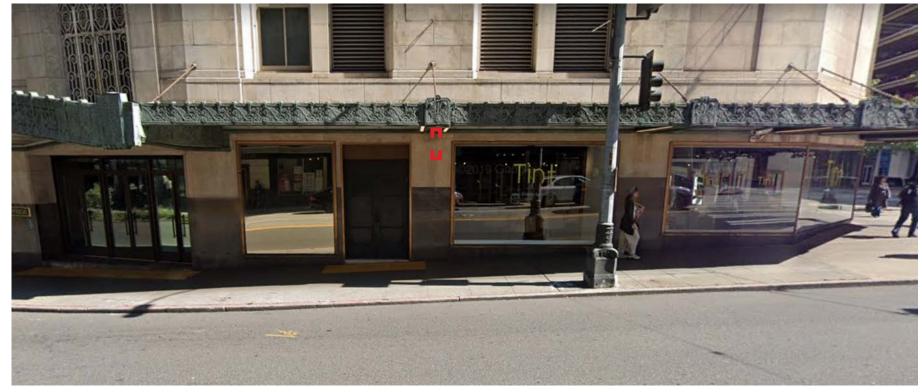
OLIVE WAY PROPOSED NEW BLADE SIGNAGE CABINET TO MATCH EXISTING CABINET DIMENSIONS, FINISHES AND ATTACHMENT DETAIL.

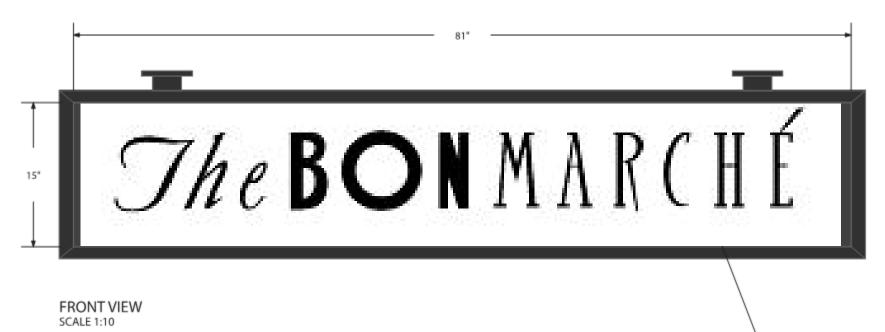
TRANSLUCENT WHITE POLYCARBONATE FACE W/ PLOTTER CUT MATTE BLACK VINYL GRAPHICS, APPLIED DIRECT TO FIRST - SURFACE, INSTALL INTO EXISTING CABINET,

CONFIRM FINAL SIZE OF FACE BEFORE FINAL PRODUCTION

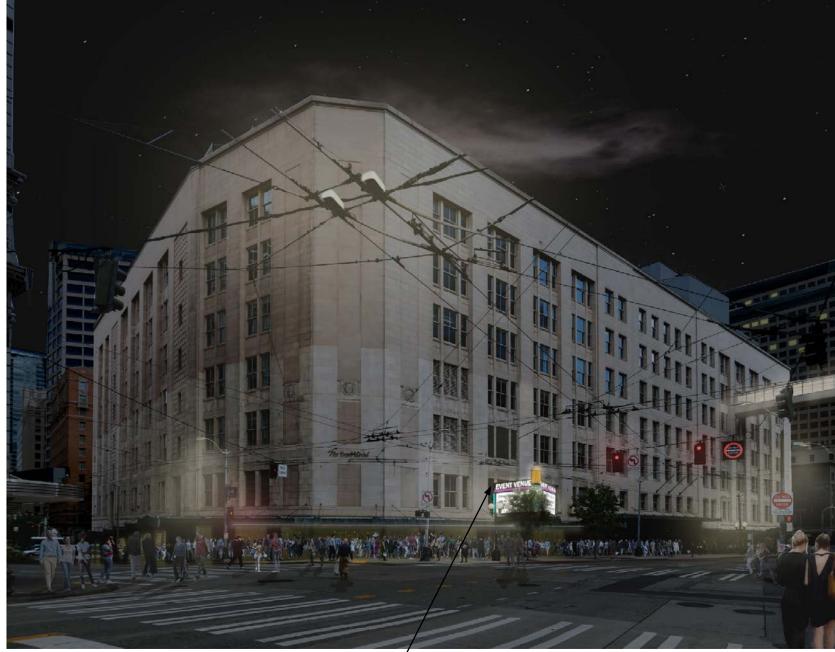
Existing Windows to Be Removed and Stored.

Infill Window Openings with Dark Bronze Metal Panel
